# KINETICS NOISE CONTROL TEST REPORT #AT001109

KINETICS DRAWING NUMBER: AT001109A

KINETICS DRAWING NUMBER: AT001109B

RE: KMUW Radio Station  
Acoustical Testing of Studio Floor  
Project No. 1650000859

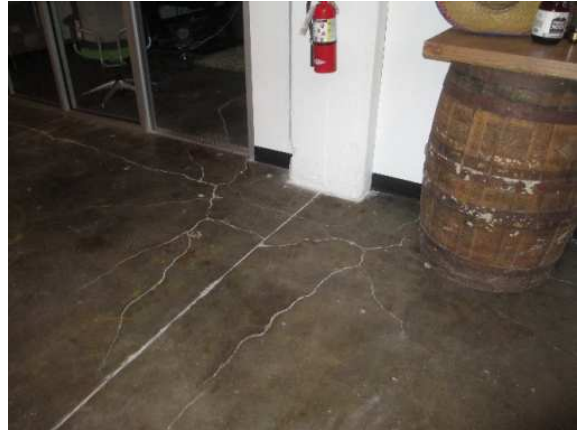
During construction of KMUW's interior tenant finish, significant deflection was discovered in the structural slab supporting the space. Subsequent structural testing indicated the 9" thick concrete slab had inadequate reinforcing, likely due to cumulative damage from the fires. These conditions caused the design team to revisit many aspects of the tenant fitout to address the structural issues, including redesigning the floating floors in the studio spaces for considerable less load.

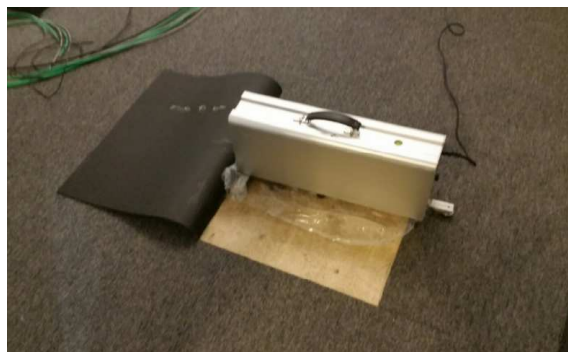
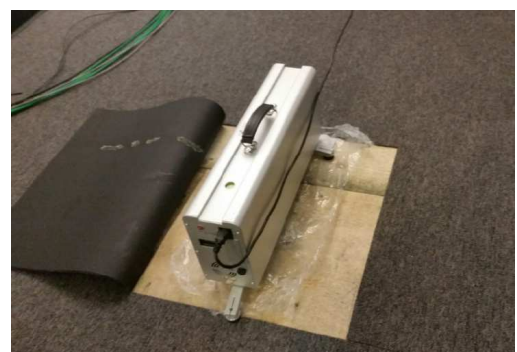
Carpet tile had been installed days before the site visit was conducted. We were able to peel back one of the 24"x24" carpet tiles so impact testing could be conducted on the plywood flooring underneath. A thin layer of plastic was placed down on the plywood to prevent any tapping machine hammers from sticking. Due to the size of the tapping machine and carpet tile, and the desire to do the least amount of modifications to the studio floor for concerns of not being able to reinstall the carpet back to its original finish, we were only able to place the tapping machine in two of the four testing positions described in *ASTM E1007*. All materials met the aging periods as stipulated by *ASTM*.

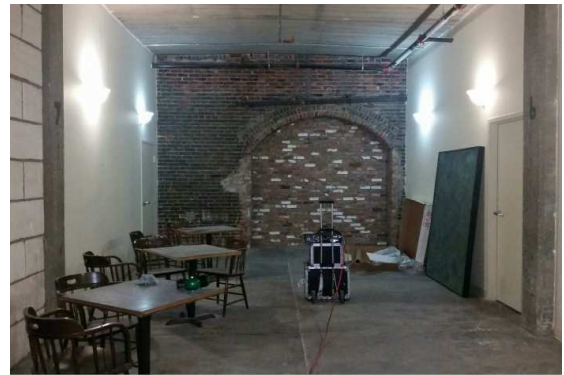
Original floor slab testing (for delta calculations) – A portion of the second floor slab was exposed in the Lobby area, with a vacant tenant space below it. The stairway between the first and second level was open to both levels. This arrangement was ideal for the tapping test since associated noise from the Lobby space could be effectively isolated when the receive room door was shut. However, extraneous noise during the airborne test was too much to overcome even with the door closed, so an ASTC rating for the original floor slab could not be obtained.

(Second floor lobby space used for original conditions testing)

Therefore, we used the computer program INSUL to estimate the noise reduction of a 9” concrete slab. Since the concrete structure had been damaged through the years due to fire incidents, lightweight concrete was used in lieu of normal weight to account for any structural degradation and density.
