# KINETICS NOISE CONTROL ACOUSTICAL PERFORMANCE TEST REPORT

ASTM E90 SOUND TRANSMISSION LOSS TESTING ON RT-7, NOISE BARRIER PANEL

M4936.01-113-11-R0

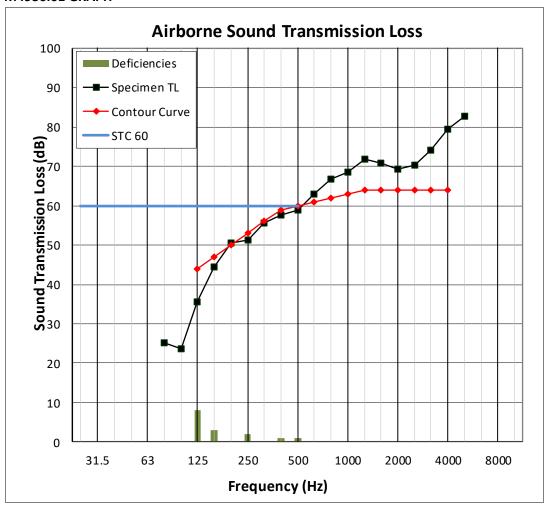
# M4936.01 GRAPH

FREQ	BACKGROUND	ABSORPTION	SOURCE	RECEIVE	SPECIMEN	95%	NUMBER
	SPL		SPL	SPL	TL	CONFIDENCE	OF
(Hz)	(dB)	(m²)	(dB)	(dB)	(dB)	LIMIT	DEFICIENCIES
80	38.2	6.5	108	78	25	2.05	-
100	35.4	6.6	108	79	24	2.42	-
125	37.4	6.5	107	67	36	1.29	8
160	41.6	5.4	110	63	44	1.01	3
200	40.7	5.2	110	57	50	0.44	0
250	32.9	5.9	107	52	51	0.51	2
315	26.4	6.0	108	50	56	0.50	0
400	22.4	6.7	110	49	58	0.46	1
500	26.8	6.7	108	46	59	0.44	1
630	21.4	6.3	107	40	63	0.32	0
800	16.9	6.6	106	36	67	0.19	0
1000	14.0	6.7	107	35	68	0.21	0
1250	13.8	7.1	106	30	72	0.21	0
1600	12.4	7.5	105	30	71	0.17	0
2000	10.8	8.1	105	32	69	0.24	0
2500	9.9	9.1	106	30	70	0.23	0
3150	9.1	10.7	104	24	74	0.18	0
4000	10.2	13.1	102	16	80	0.44	0
5000	13.7	16.7	103	12	83	0.36	-
STC RATIN	iG	60	(Sound Transmission Class)				
DEFICIENC	CIES	15	(Sum of Defi	ciencies)			
OITC RATI	OITC RATING		(Outdoor-Indoor Transmission Class)

Transmission loss (TL) at each 1/3 octave frequency is the average source room sound pressure level minus the average receive room sound pressure level, plus, 10 times the log of the specimen area divided by the sound absorption of the receive room with the sample in place.

To obtain the Sound Transmission Class (STC), read the TL of the contour curve at 500 Hz. The sum of the deficiencies below the contour curve must not exceed 32. The maximum deficiency at any one frequency must not exceed 8.

The Outdoor-Indoor Transmission Class (OITC) is calculated by subtracting the logarithmic summation of the TL values from the logarithmic summation of the A-weighted transportation noise spectrum stated in ASTM E1332.

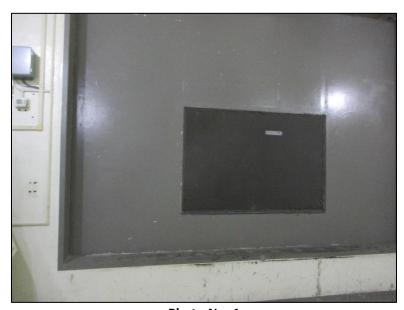
Photo No. 1
Receive Room View of Installed Test Specimen

MATERIAL	ACTUAL THICKNESS (inches)	AVERAGE WEIGHT	
KNM-200B	0.20	2.0 lbs/ft <sup>2</sup>	
FIBERGLASS	2.00	0.5 lbs/ft <sup>2</sup>	
KNM-200B	0.20	2.0 lbs/ft <sup>2</sup>	
GYPSUM BOARD	0.625	2.1 lbs/ft <sup>2</sup>	
KNM-200B	0.20	2.0 lbs/ft <sup>2</sup>	
FIBERGLASS	2.00	0.5 lbs/ft <sup>2</sup>	
KNM-200B	0.20	2.0 lbs/ft <sup>2</sup>	
GYPSUM BOARD	0.625	2.1 lbs/ft <sup>2</sup>	
KNM-200B	0.20	2.0 lbs/ft <sup>2</sup>	
FIBERGLASS	2.00	0.5 lbs/ft <sup>2</sup>	
KNM-200B	0.20	2.0 lbs/ft <sup>2</sup>

The test specimen had a nominal thickness of 8-7/16". All material layers were 72" by 48" sheets.

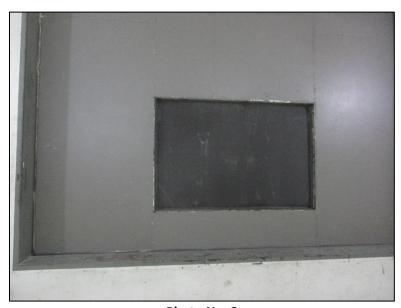
Photo No. 2 Source Room View of Installed Test Specimen

The specimen plug was removed from the filler wall assembly. The specimen was placed on an isolation pad in the test opening. Duct seal was used to seal the perimeter of the specimen to the test opening on both sides. The interior side of the specimen, when installed, was approximately 1/4" from being flush with the receive room side of the filler wall. A stethoscope was used to check for any abnormal air leaks around the test specimen prior to testing. Operable portions of the test specimen, if any, were cycled at least five times prior to testing.
